Electrostatic Discharge Interference In The Clinical Environment

*Brief cold snaps or humidification disruptions
can cause BSD problems.*

WALLACE R. ELLIOTT, MS, CCE
GILBERT GIANETTI

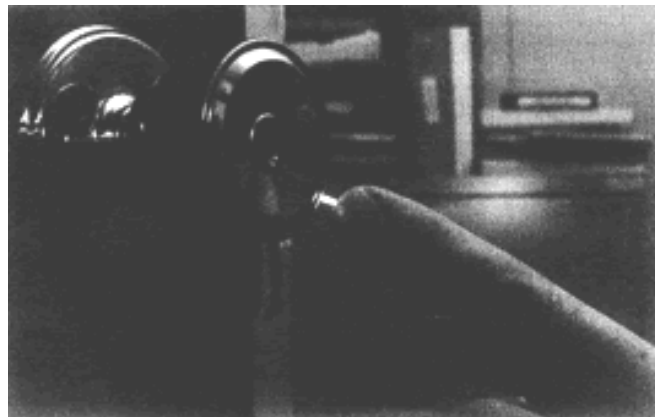
Figure 1. Simulated electrostatic discharge between a finger and a door knob.

Proving that ESD resulted in the malfunction of a device can be very difficult. One those occasions when apparatus obviously begins to operate erratically, coincidental with perception of an arc (Figure 1), diagnosis may be easy. When no arc is seen, evidence of the cause can be impossible to produce. Rebooting an ESD-influenced computer found to be operating in an error mode often brings a return to normal operation. After rebooting, it may be that no evidence of the malfunction will remain. Where evidence does remain it is likely to be microscopic and undetectable with common troubleshooting tools.

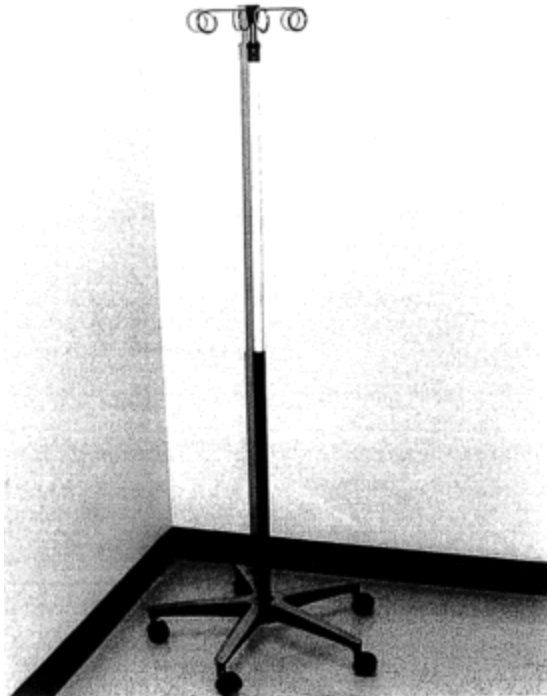
Figure 3. IV pole modified with an electrically insulative covering to reduce the probability of ESD to this device.

Restriction of access to, or electrical isolation of, a site to which ESD is known to produce undesirable consequences can be an effective

means of eliminating a recurring problem. When an IV pole was shown to act as an antenna for an EMI signal generated by ESD to the pole. For example, an insulative pole covering was employed.

(Figure 3).
